WOOD I-JOIST INSTALLATION TO WOOD

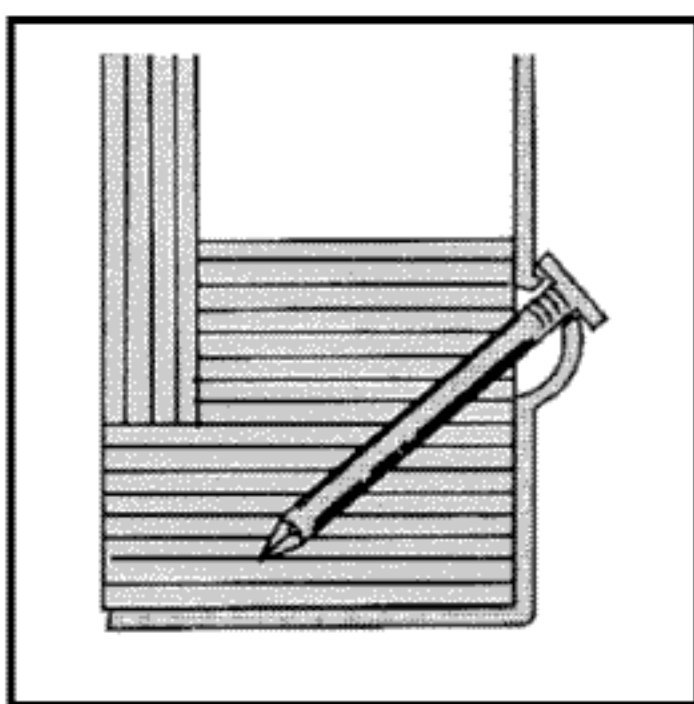
CORRECT SLANT NAIL INSTALLATION:

Always secure wood I-joist using 10d x 1-1/2" nail driven at a 45° angle and firmly seated.

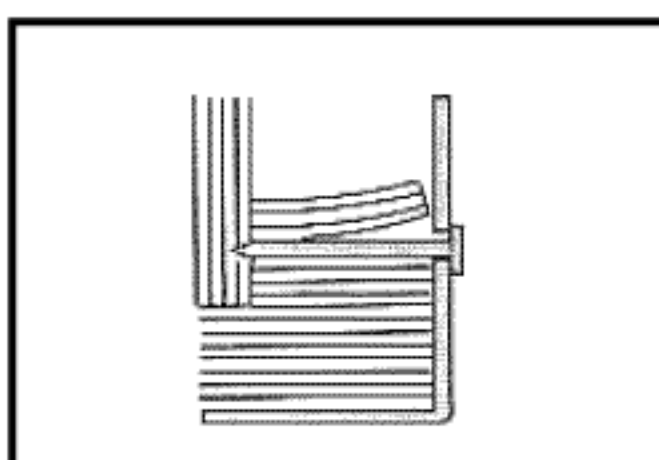
COMMON NAILING ERRORS

Wrong Angle:
When a nail is driven into the bottom flange of the wood I-joist parallel to the glue lines, separation of veneers can occur which substantially reduces the design loads of the connection.

Install only the specified nails. The flanges of wood I-joists may split if larger diameter nails or longer nails are installed. Do not install nails larger than 16 penny common (0.162 inch diameter) into the web stiffeners in the wood I-joist.

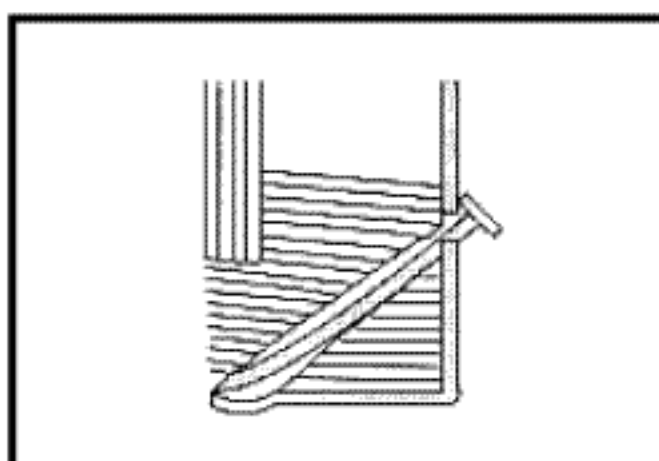
Nail too Long:
When using nails longer than USP Lumber Connectors recommended nails, splitting of the bottom flange can occur and also raise the wood I-joist off the seat. This can result in uneven surfaces and squeaky floors, along with reduced allowable loads.

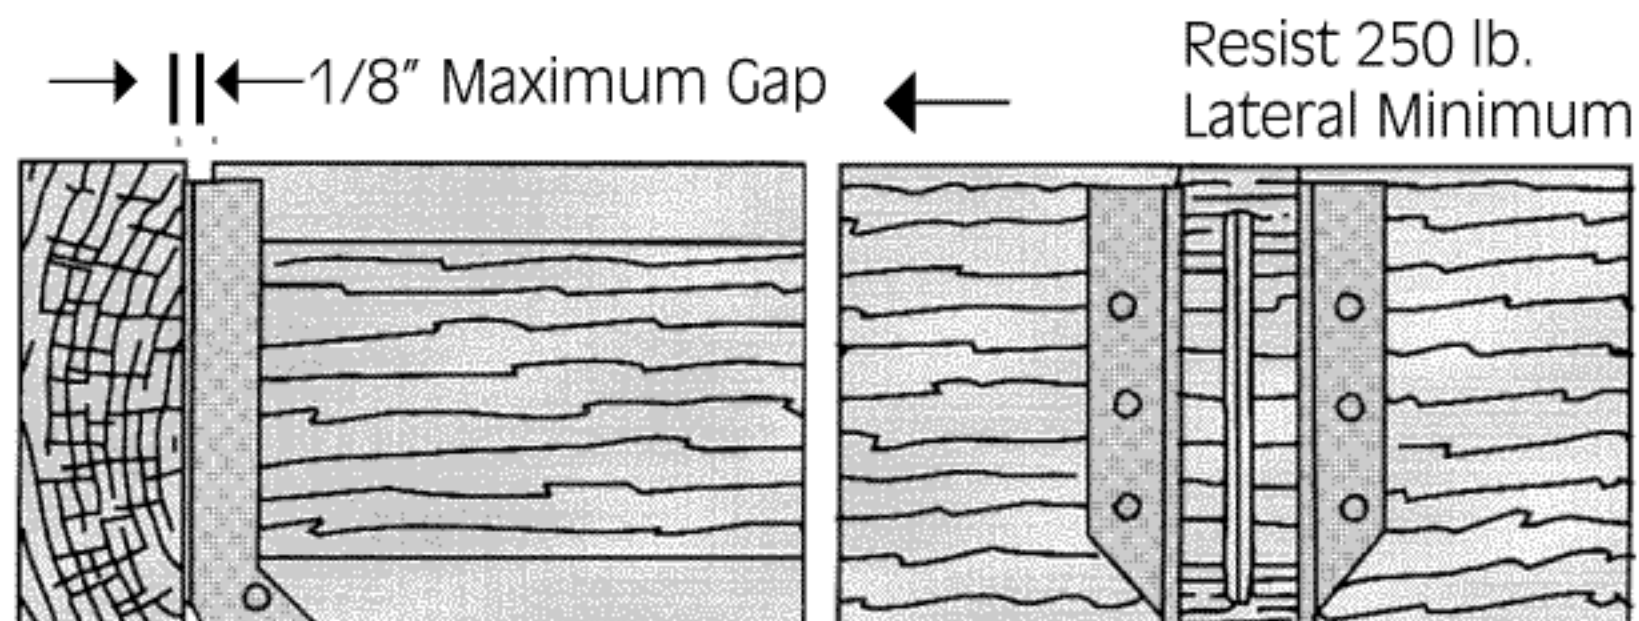
Without Web Stiffeners:

Hangers without web stiffeners must support I-joist top flange and provide minimum 250-pound lateral resistance with no more than 1/8" horizontal deflection.

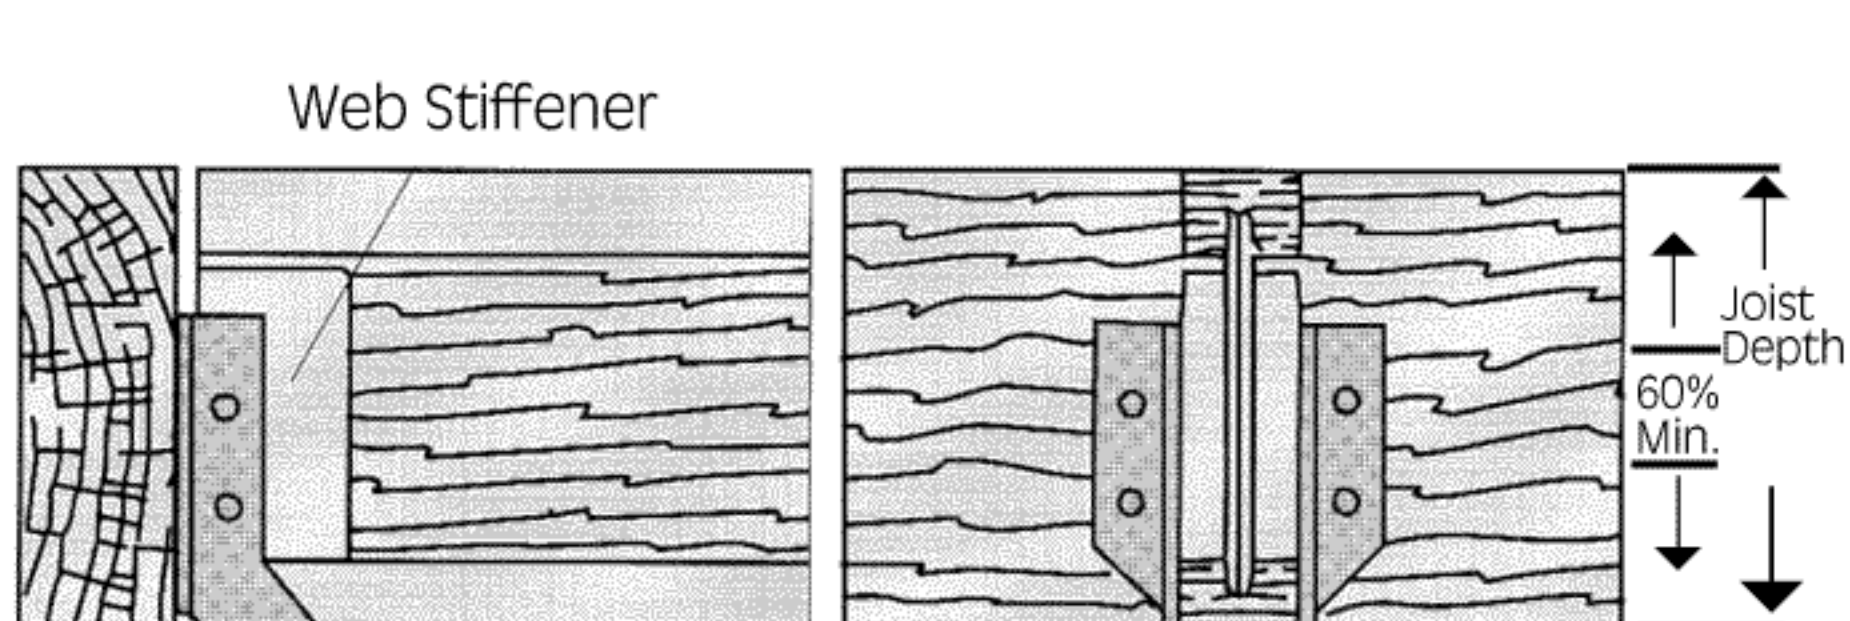
With Web Stiffeners or Solid Members:

Hangers for joists with web stiffeners must support a minimum of 60% of joist depth.
